Case Presentation Made Easy

Case Study Presentation

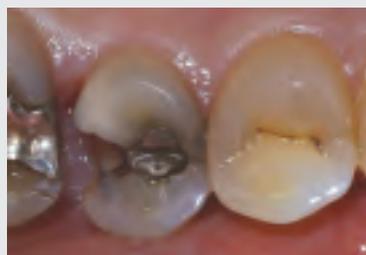
A woman presented with discomfort in the upper right region of the mouth. Clinical examination and radiographs revealed that tooth No. 4 had a large amalgam restoration that was fractured with recurrent decay beneath the restoration extending near the pulp (Figure 1). The patient complained of discomfort on biting hard foods and

Figure 1—Preoperative view of the failing amalgam restoration in tooth No. 4.

After the patient agreed to the recommended treatment, she was scheduled for the procedure. All the risks, benefits, and alternatives were discussed with the patient. The patient was anesthetized and a dental dam was placed on tooth No. 4. Amalgam removal was achieved using a Barracuda bur (Kisco Dental Products, Wichita, Kan, www.kiscodental.com). Recurrent decay was present underneath the restoration as had been suspected (Figure 3). An intraoral picture was taken to illustrate to the patient exactly how deep the caries had extended underneath the previous restoration. Using the DemoDent model, the progression of decay through the layers of the tooth was further described. Further clean out of decay using a No. 6 round bur revealed that decay had progressed into the pulpal area of tooth No. 4 and that root canal treatment would be required to properly restore the tooth (Figure 4). After root

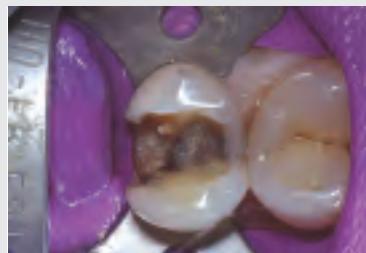
Figure 3—The recurrent decay evident after amalgam removal.

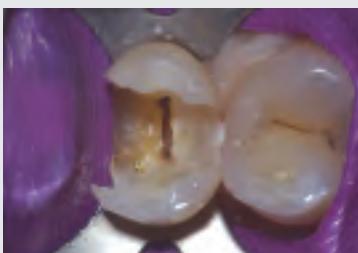
Figure 4—Decay extending into the pulpal area.

canal therapy was completed, a titanium alloy post (ParaPost, Coltène Whaledent Inc, Cuyahoga Falls, Ohio, www.coltenwhaledent.com) was cemented using an opaque shade of self-etch, self-adhering resin cement (Maxcem, Kerr Corp, Orange, Calif, www.kerrdental.com) and the core was built-up using a dual-core material

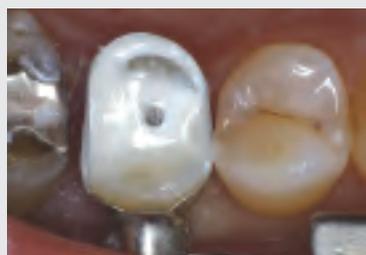
Figure 5—Placing the post and core.

(CosmeCore, Cosmedent, Inc, Chicago, Ill, www.cosmedent.com) (Figure 5). Using an LED curing light (L.E.Demetron II, Kerr Corp), the core was cured for 25 seconds. Then the tooth was prepared for a full-coverage crown. Because margins need to be on solid tooth structure and the decay had spread below the gingival

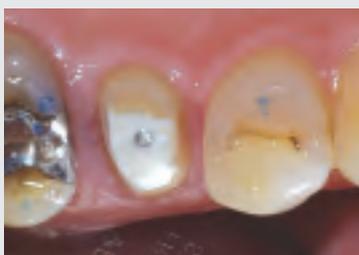
Figure 6—Gingival retraction paste was placed to control bleeding of the soft tissue.

margin, the crown margins were extended subgingivally. A gingival retraction paste (Expasyl, Kerr Corp) was used to control the bleeding of the gingival tissues (Figure 6). After hemostasis was achieved, an impression was taken using a polyvinylsiloxane material (Take 1, Kerr Corp).

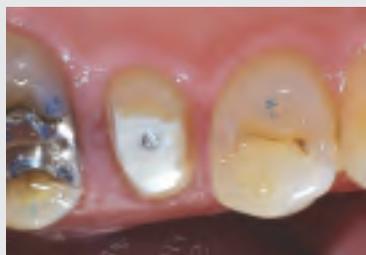
Figure 7—Clinical view of the final preparation at the re-evaluation appointment.

Two weeks later the patient returned for placement of the porcelain-fused-to-metal crown. The provisional restoration was removed and the preparation was inspected for final cementation (Figure 7). After a bitewing x-ray was taken to confirm full seating of the crown and the contacts and margins verified, the crown restoration was cemented (Maxcem, Kerr Corp). The patient was very pleased with the final restoration (Figure 8).

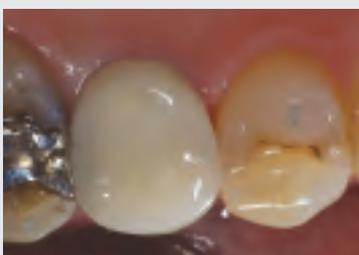
Figure 8—Final porcelain-fused-to-metal restoration.
