Recreating Mother Nature With Direct Resin Restorations

Ara Nazarian,
DDS

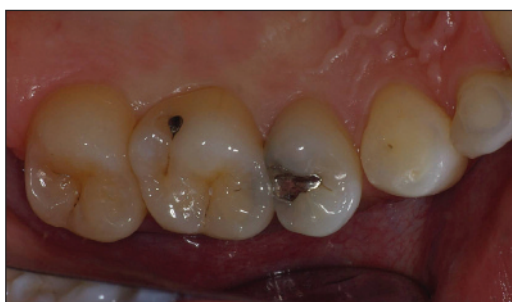
Figure 1. Preoperative condition showing failing amalgam restorations.

was fractured with recurrent decay. Tooth No. 14 presented with interproximal decay (Figure 1). The radiograph exhibited some recurrent decay beneath the restoration extending close to the pulp on tooth No. 13. The patient complained of discomfort upon biting hard foods and experienced occasional sensitivity to cold. Once the images of the failing amalgam restoration were captured on the monitor, I asked the patient a series of questions. "Mrs. Smith, how long ago was this amalgam restoration placed?" The patient answered that it was hard to remember exactly, but she thought it was placed more than 20 years ago. Using the DemoDent patient education model (DemoDent) (Figure 2), I then described the portion illustrating what can happen to a tooth when a restoration starts to fail. "Mrs. Smith, nothing lasts forever, especially when it is subject to the harsh conditions in the mouth—ie, hot and cold, biting forces, chewing, and acidic changes; it appears that your filling is cracked which has been allowing bacteria to leak underneath the filling. Often, the damage is not seen immediately because there are no major symptoms until the decay reaches the nerve of the tooth. Our experience with replacing these fillings has shown us it is best to remove the filling and clean out the decay before the nerve is affected. If there is enough tooth structure remaining after cleaning the decay out, then a new filling material can be placed. If there is not enough healthy tooth structure remaining after cleaning out the decay, then the tooth may need a core and crown to restore it to proper form and function." After explaining the situation using the image on the screen and the anatomical model, I have found that patients seem to understand their dental condition better and are very eager to get started. The patient elected to have the restorations replaced with bonded composite restorations.

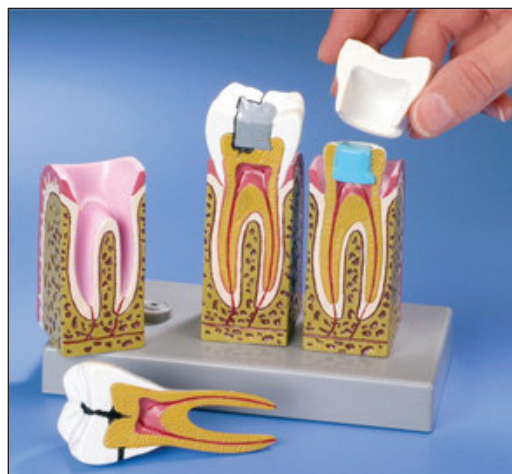
Figure 2. DemoDent patient education model illustrating the presenting condition.

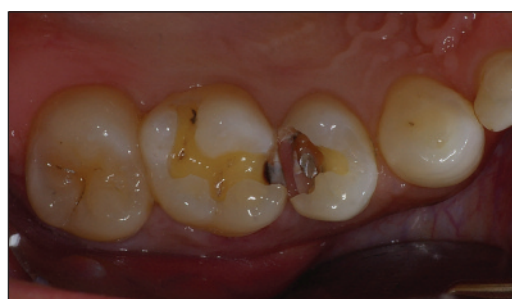
Figure 3. Removal of the amalgam restorations.

the defective amalgams (Figure 3). Upon removal of the amalgams, it was found that caries were present in the deepest regions of the preparations (Figure 4). This was carefully removed using a slow-speed hand-piece and large round bur (Cerabur [KOMET USA]) (Figure 5). The preparations were extended to remove the caries in the palatal fissure region for tooth No. 14, and the interproximal areas for both teeth Nos. 13 and 14 (Figure 6). A sectional matrix band (V3 Ring [TrioDent]) was placed over the mesial margin of tooth No. 14 such that its position and shape would enable placement of a composite with an optimal mesial contour (Figure 7).

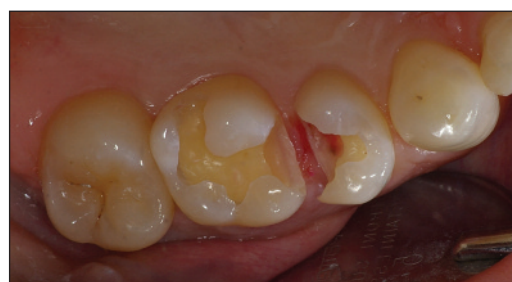
Figure 4. Caries still present under the restorations.

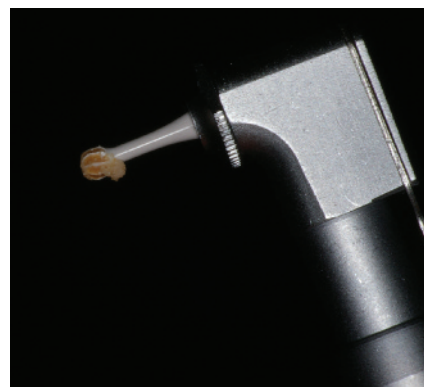
Figure 5. A round bur (Cerabur [KOMET USA]) was used for removing remnant decay.

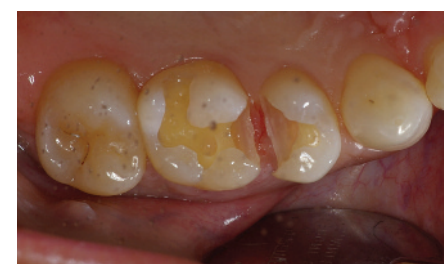
Figure 6. Full removal of decay.

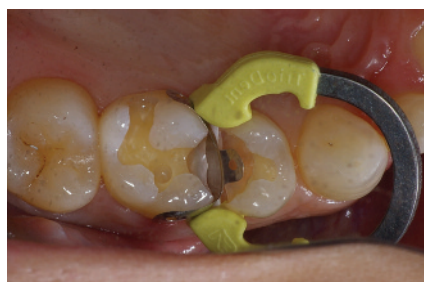
Figure 7. Placement of V-3 Band (Kerr) and ring.

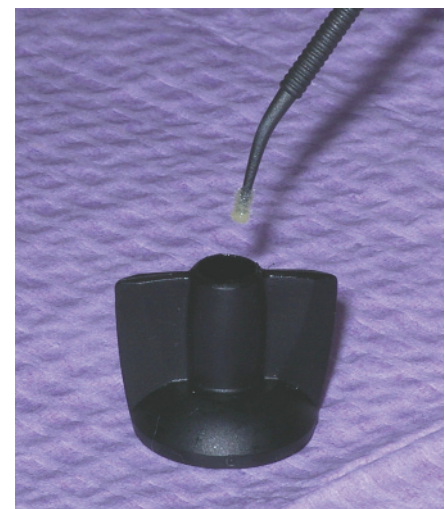
Figure 8. Bonding agent (OptiBond All in One Bond [Kerr]) was placed.

For optimal contour, gingival seal, and tooth separation, a wedge was inserted between teeth Nos. 13 and 14. Using the V3 forceps, the V3 ring was placed over the wedge. It was important to burnish the band in the desired contact area against the adjacent tooth and make sure there was no springback of the band. This would ensure an excellent contact. Once tooth No. 14 was isolated by the matrix band, it was dried and a seventh generation adhesive (OptiBond All-In-One [Kerr]) was applied to all internal aspects of the preparation, including the cavosurface margins, for 20 seconds (Figure 8). The solution was gently agitated with a regular microbrush applicator tip. Because no rinsing of a separate etchant is required when using a self-etching technique, the collagen network is not subjected to the potential collapse associated with over-drying the dentin or being too wet after rinsing the etchant off the substrate. As mentioned, over-drying can cause collapse of the delicate collagen network, which is then a barrier to the monomers in the primer adhesive that must infiltrate through this organic zone to the etched dentin surface resulting in sensitivity. Another layer of bond was placed, dried, and then cured for 15 seconds with an LED curing light (Demi [Kerr]). In order to reduce polymerization shrinkage stress, a flowable resin (shade A1) (Premise Flowable [Kerr]) was placed as the initial layer of composite material. Flowable composites have a relatively low modulus and act as an elastic gradient between the dentin and the stiffer microhybrid, thus moderating polymerization shrinkage stress at the margins. Their low viscosity also wets the internal surfaces of the prepared cavity and helps ensure a well-adapted first layer.

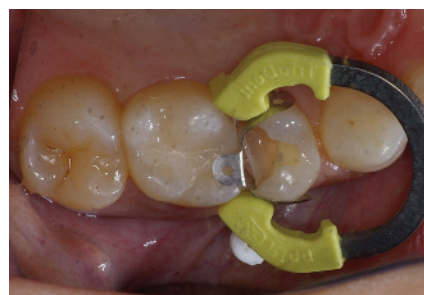
Figure 9. Composite (Herculite Ultra [Kerr]) cured on No. 14.

than the dentin or opaque forms, allowing it to blend in with the rest of the tooth surface. Even with these latest generations of composite materials, there is significant stress that is placed on the tooth/resin interface due to shrinkage of the resin, so it was important to place the composite restoration with an incremental technique. The first layer was placed on the gingival floor and proximal box over the flowable composite, the second and third layers were placed diagonally, and the last increment was used to complete the filling in the occlusal portion of the cavity. It was essential to cure each layer completely for 20 seconds before placing the next level of composite. Also, it was important to remember that composite resin, which is bounded on all sides by cavity walls and placed in simultaneous contact with those walls and cured, is associated with the highest stress at the bond (Figure 9).

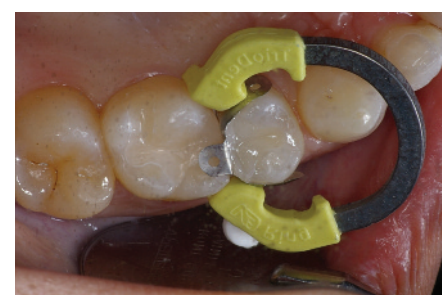
Figure 10. Composite restoration (Herculite Ultra [Kerr]) completed on No. 13.

Once tooth No. 14 was completely built up, cured, trimmed, and polished, the sectional matrix was placed on tooth No. 13. Care was given to follow the same protocol as discussed previously with restoring tooth No. 14 (Figure 10). Prior to implementing that technique, since this preparation was in such close proximity to the nerve after cavity removal, a small layer of resin modified glass ionomer (Riva Light Cure [SDI]) was placed as a base. The patient was informed that, if the tooth caused persistent pain, it might require endodontic therapy. Once the restoration was filled and cured it was shaped, trimmed and finished using carbides (Q-Finishers, KOMET USA).

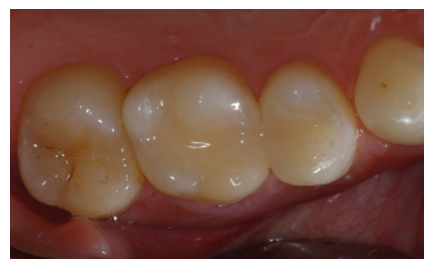
Figure 11. The final restorations; finished and polished.

Finally, the occlusion was checked and verified making sure there were no interferences in lateral and protrusive movements (Figure 11). The patient was so pleased with the restorations that she had professional tooth whitening on her teeth (Pola, In-Office [SDI]) to further enhance her smile.
